White River Flowage
Flowering rush
Post - Early Detection and Response 3-yr program

Year 4 Activity Report

Monitoring survey and handpulling activities 2018

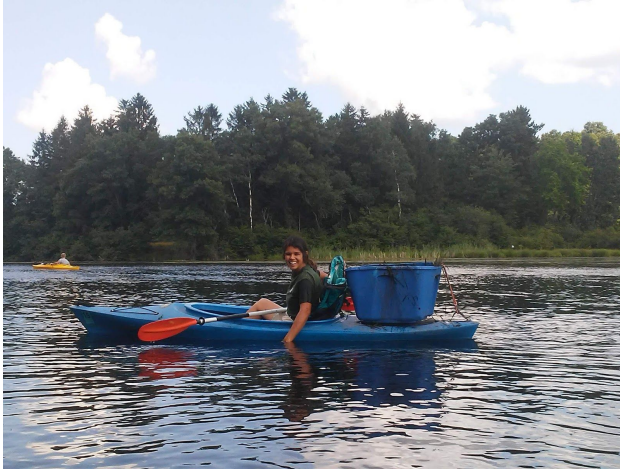
Top Left: AmeriCorps team member works in the channel pulling flowering rush.

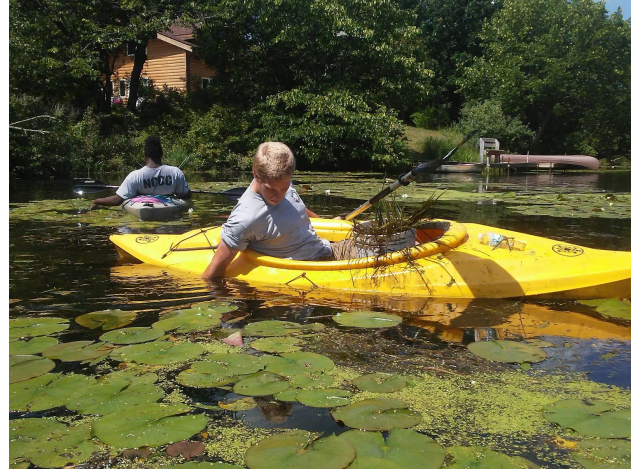
Top Right: AmeriCorps team member pulls flowering rush at the downstream end of ground zero.

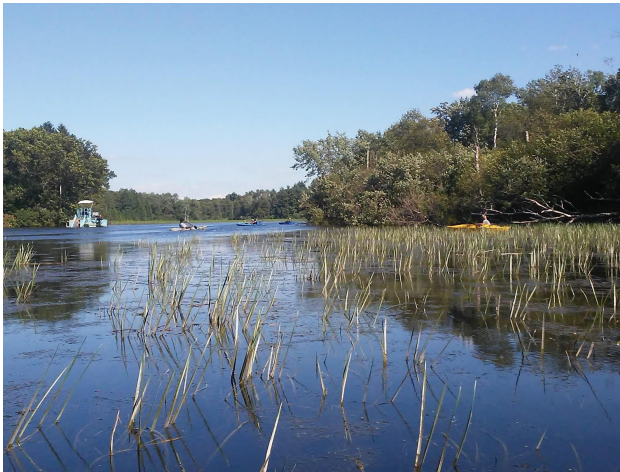
Bottom Left: The view of flowering rush at ground zero, looking downstream. Illustrated here is the scattered density (as outlined on the map below) of the flowering rush in the foreground of the photo and the moderate bed in the right, center of this photo.

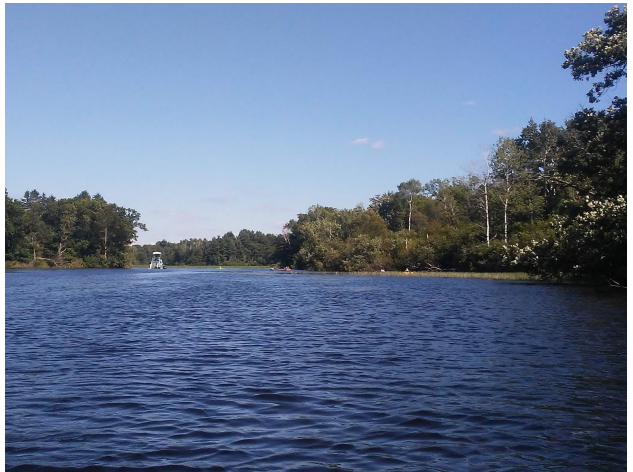
Bottom Right: Ground zero is located in the right, center of this photo. This is the extent of flowering rush on White River Flowage following the work party July 25th.

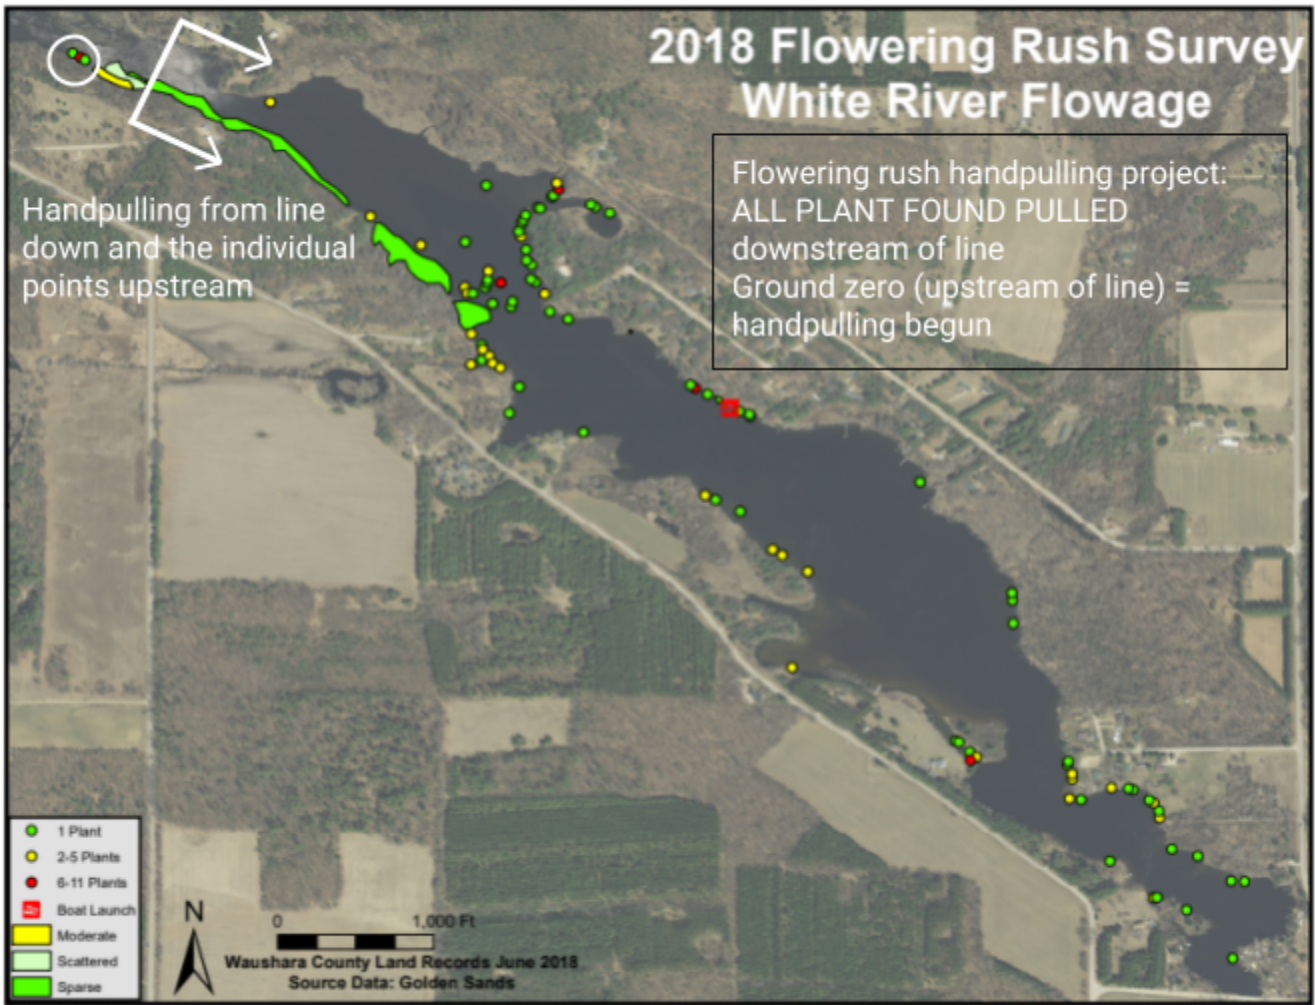
All observed flowering rush locations were recorded using a handheld GPS. The GPS points were added to aerial maps to show the flowering rush distribution. Attached below is the July map.

Results: During the survey, in the chemical treatment area (“ground zero”), plants were green, robust, and thriving. This area is the yellow and light blue polygons at the top of the maps below. The treatment area was the final location targeted for handpulling. Handpulling efforts initially focused on eliminating the spread of flowering rush in the rest of the flowage. The white line and arrows on the map indicates the upper boundary of the area where all plants downstream had been handpulled.

Following the handpulling conducted on July 24th and 25th the only area that had remaining flowering rush was at ground zero. It is important to note that while the two work events had thorough removal of flowering rush in the areas downstream of ground zero there is the potential that a few plants were either missed for the water depth or the brush they were growing in. These areas should be double checked for plant growth.

Notable observations: The current appears to create a boundary the plants do not spread beyond easily. At ground zero, no flowering rush was observed east of the channel. Major spread is from the channel westward. Major locations for monitoring would be at any collection points, such as downed trees and weed beds where drifting plants may get hung up.

Focus for volunteers: Monitoring and handpulling efforts should focus on spread downstream from ground zero. Major collection points include:

- 1) From channel westward
- 2) Downed trees where plants may snag
- 3) Weed beds immediately downstream
- 4) Small floaters on weed mats
