White River Flowage Flowering rush Post - Early Detection and Response 3-yr program

Year 5 Activity Report

Monitoring survey and handpulling activities 2019

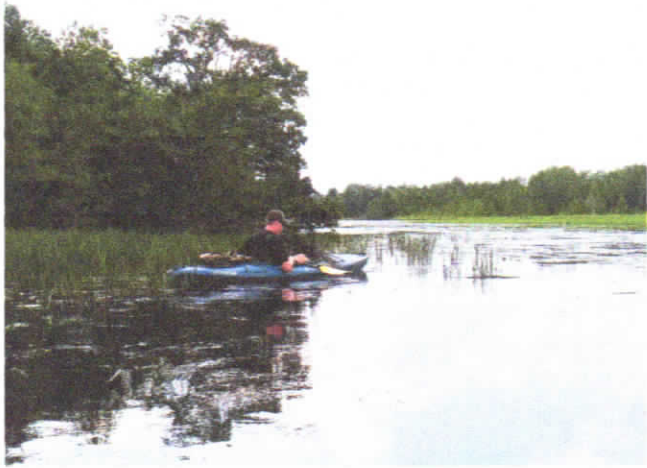
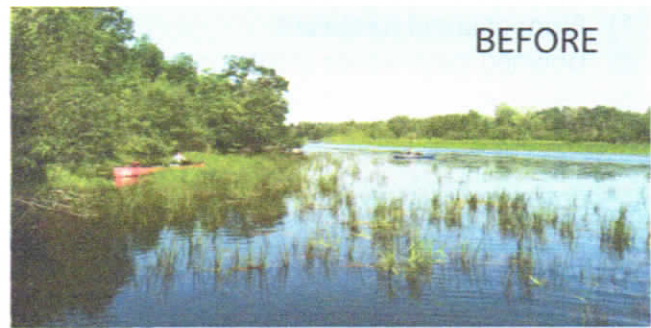
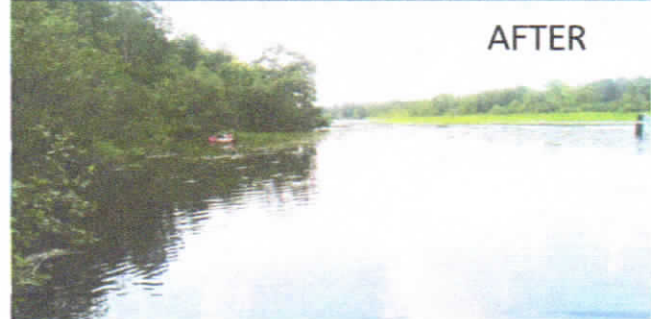
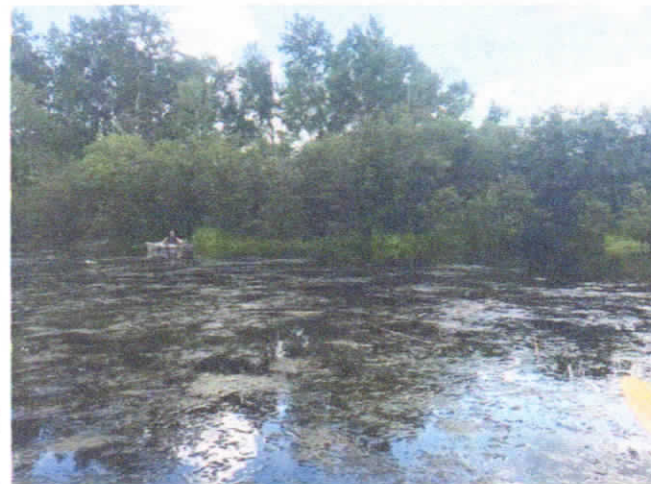
Figure 2. Pictures from the Work Event

Top Left: Austin working in ground zero, pulling flowering rush.

Bottom Left: Dean, in chest waders, got into the water at ground zero to fill a canoe full of flowering rush at a time.

Top Right: Ground zero on July 23rd, the before picture taken at the beginning of the work day and the after picture showing all that remained of ground zero upon the completion of Golden Sands led volunteer work events.

Bottom Right: Ground zero on August 3rd, the third handpulling day led by lake volunteers. Photo credit: Lynn Bockenbauer
