2015 AIS Survey: White River Flowage Curly-leaf Pondweed

Client/Project
White River Flowage

Project Location
T. of Wautoma, Waushara Co., WI

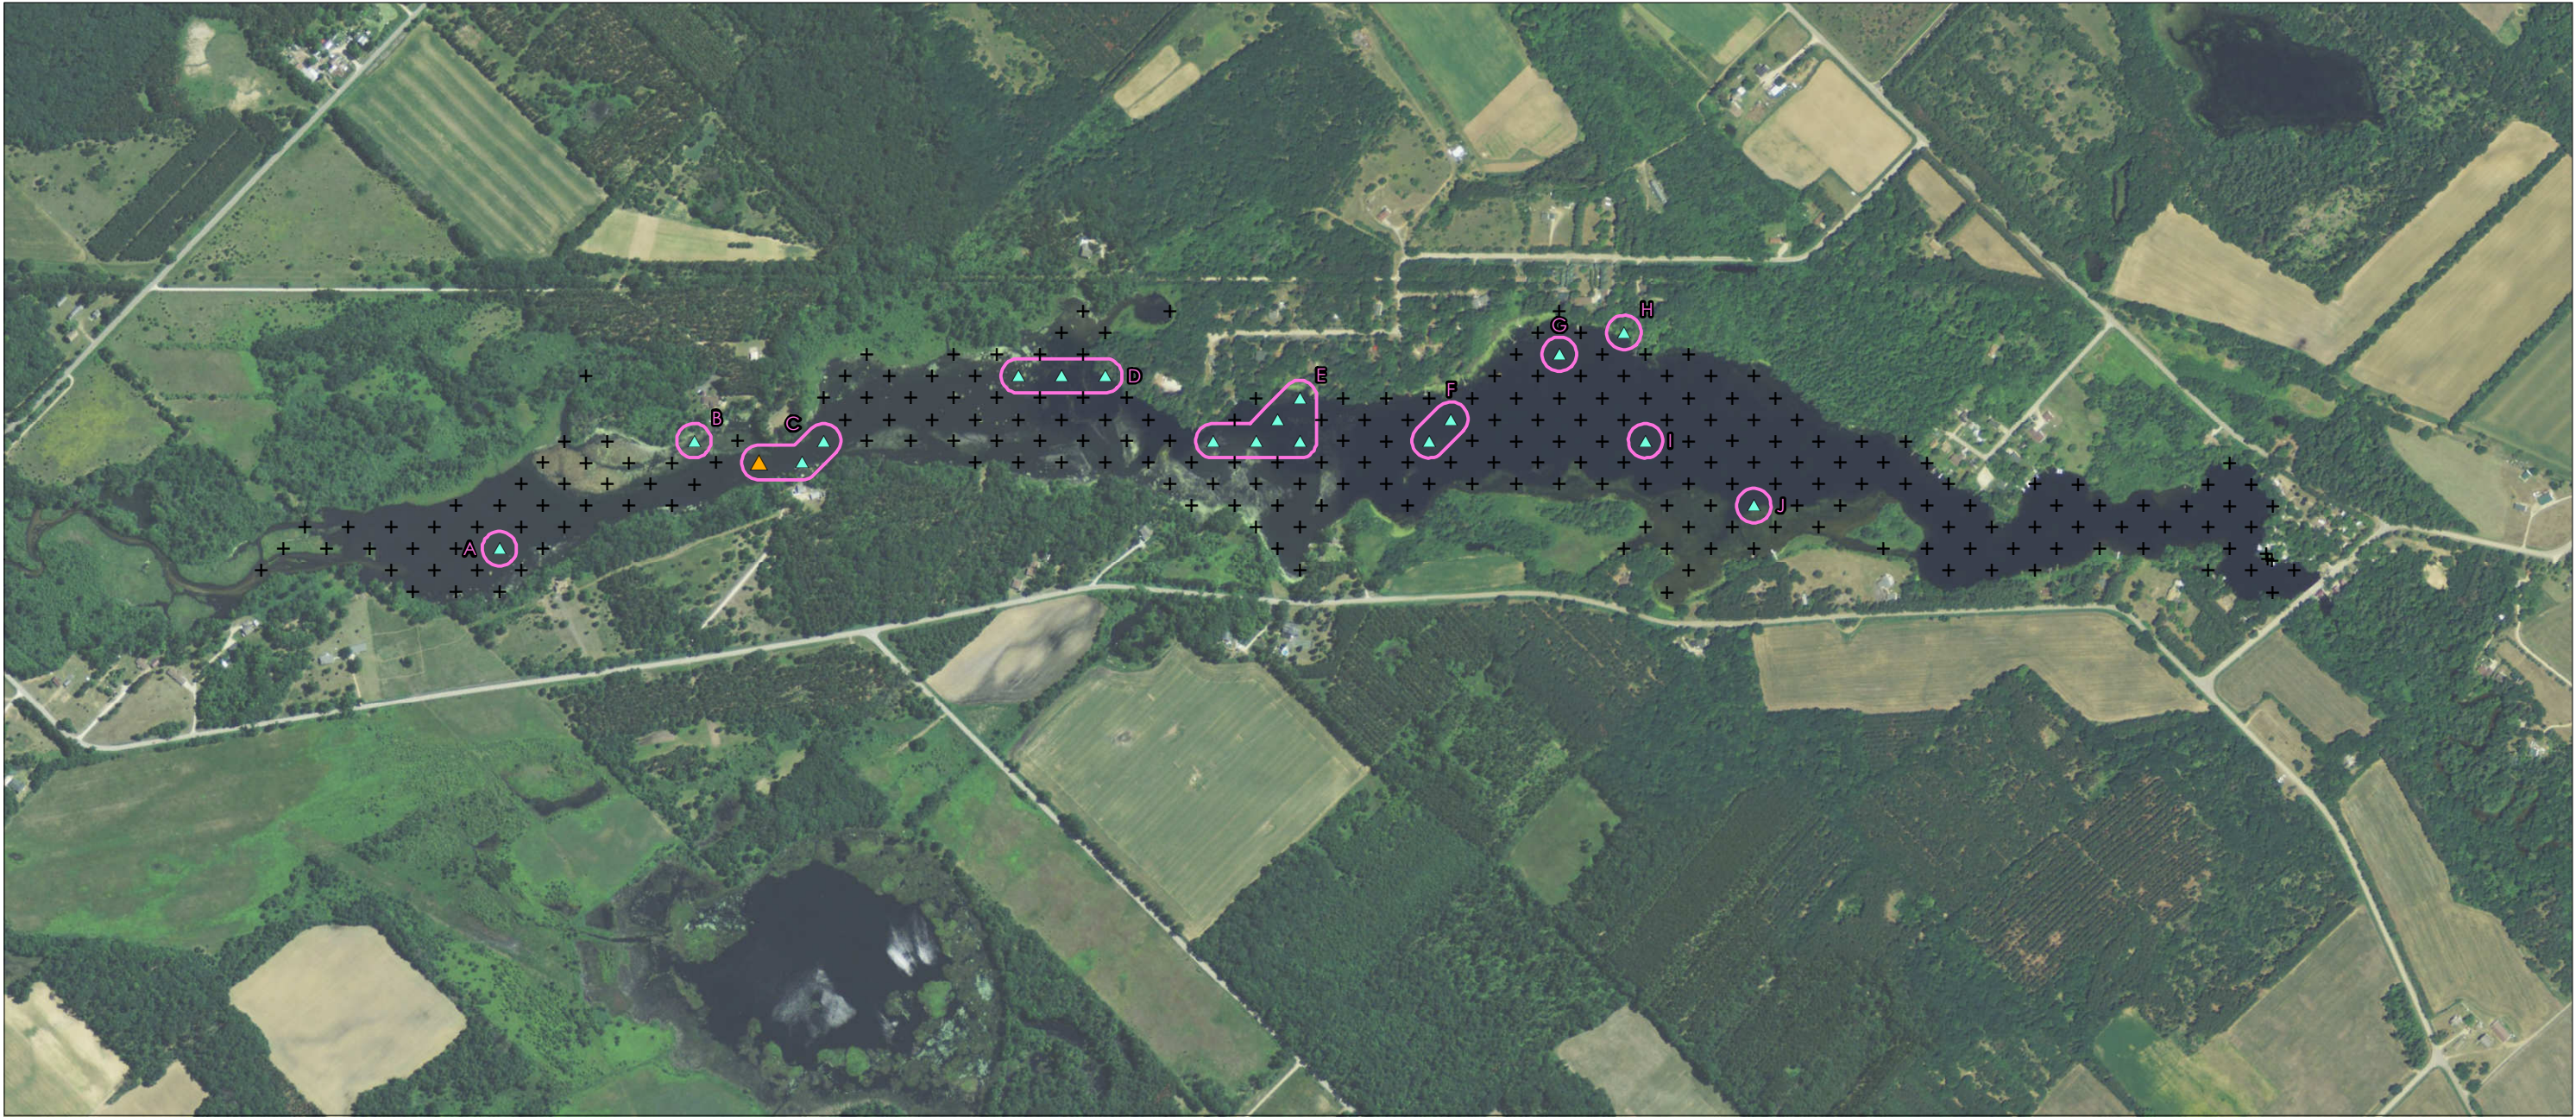
Figure No. **2**
Title

AIS Area (acreage)										
A	B	C	D	E	F	G	H	I	J	Total
0.50	0.50	1.85	2.09	3.15	1.06	0.50	0.50	0.50	0.50	11.14

* Survey conducted by James Scharl & Chris Caplan on 2015/07/07

Fullness Rating	Coverage	Description
1		Few plants. There are not enough plants to entirely cover the length of the rake head in a single layer.
2		There are enough plants to cover the length of the rake head in a single layer, but not enough to fully cover tines.
3		The rake is completely covered and tines are not visible.
