2018 Aquatic Plant Survey, White River Flowage, Waushara County, Wisconsin Re:

White River Flowage, Waushara County Survey Date: June 4, 2018

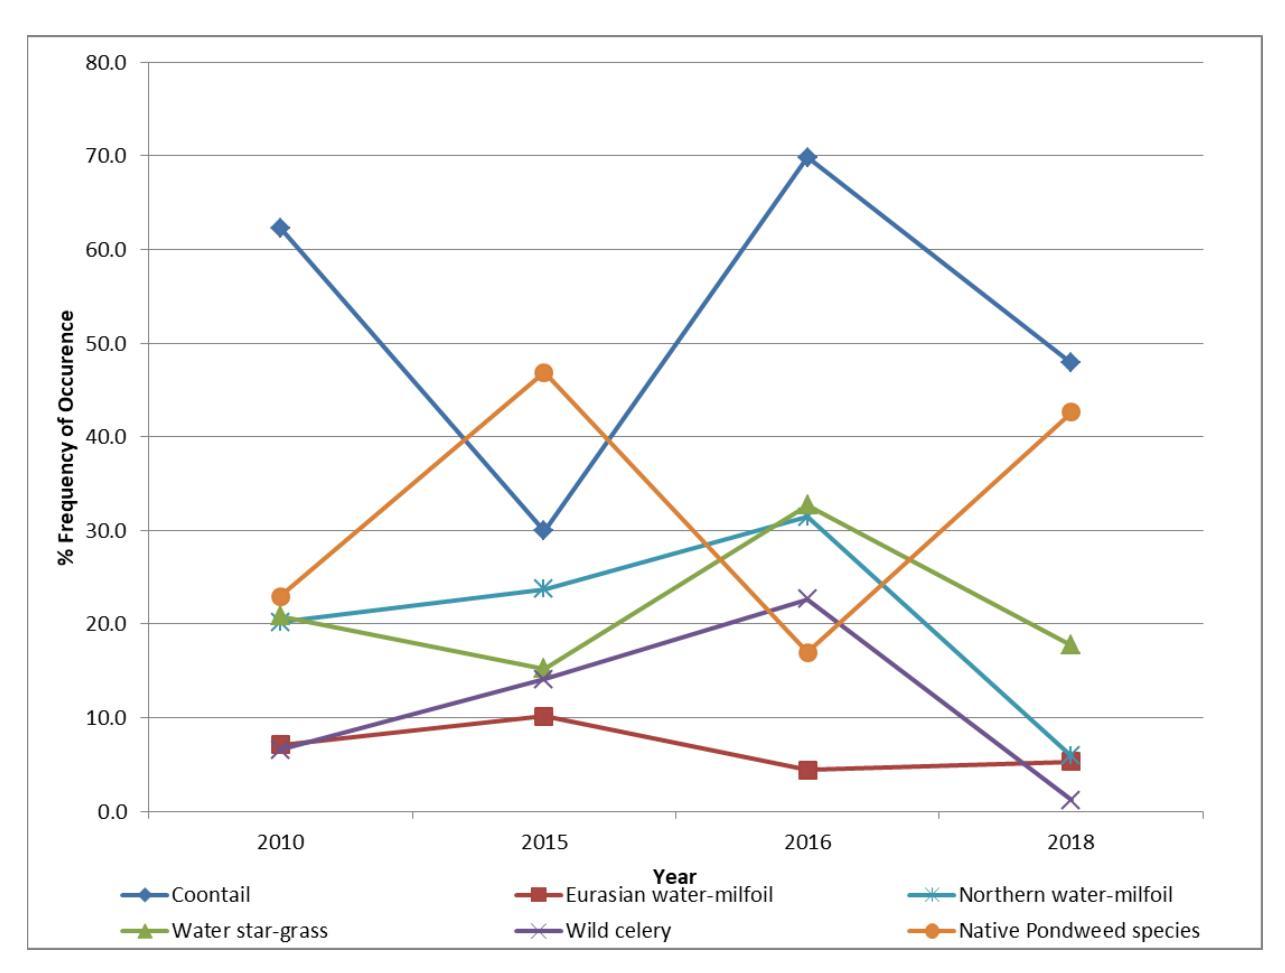
vegetated site (2.58) are all of high quality when compared to lakes within the same region (Attachment B. Tables 1-4). Results discussed here are displayed in the same format as previous surveys for the sake of comparison. Changes in EWM and the most common species present and are displayed below from 2010, 2015, 2016, and 2018.

These results indicate a stable community and with limited impact from prior management. Most common species sampled in 2018 include: common waterweed, coontail, flat-stem pondweed, water star-grass, and small duckweed. As the lake moves farther away from the past fluridone treatment additional species are expected to become established. In 2018 two new species were identified, large-leaf pondweed and leafy pondweed, both native to Wisconsin and of higher fisheries habitat quality. Some native species were indicated to have declined from 2016, but this is likely due to the early timing of the 2018 survey in order to capture the extent of CLP. Both wild celery and slender naiad are typically later-emerging species that are under represented by earlyseason surveys. These species were common in 2016 and are expected to be so in 2018 if sampled later.

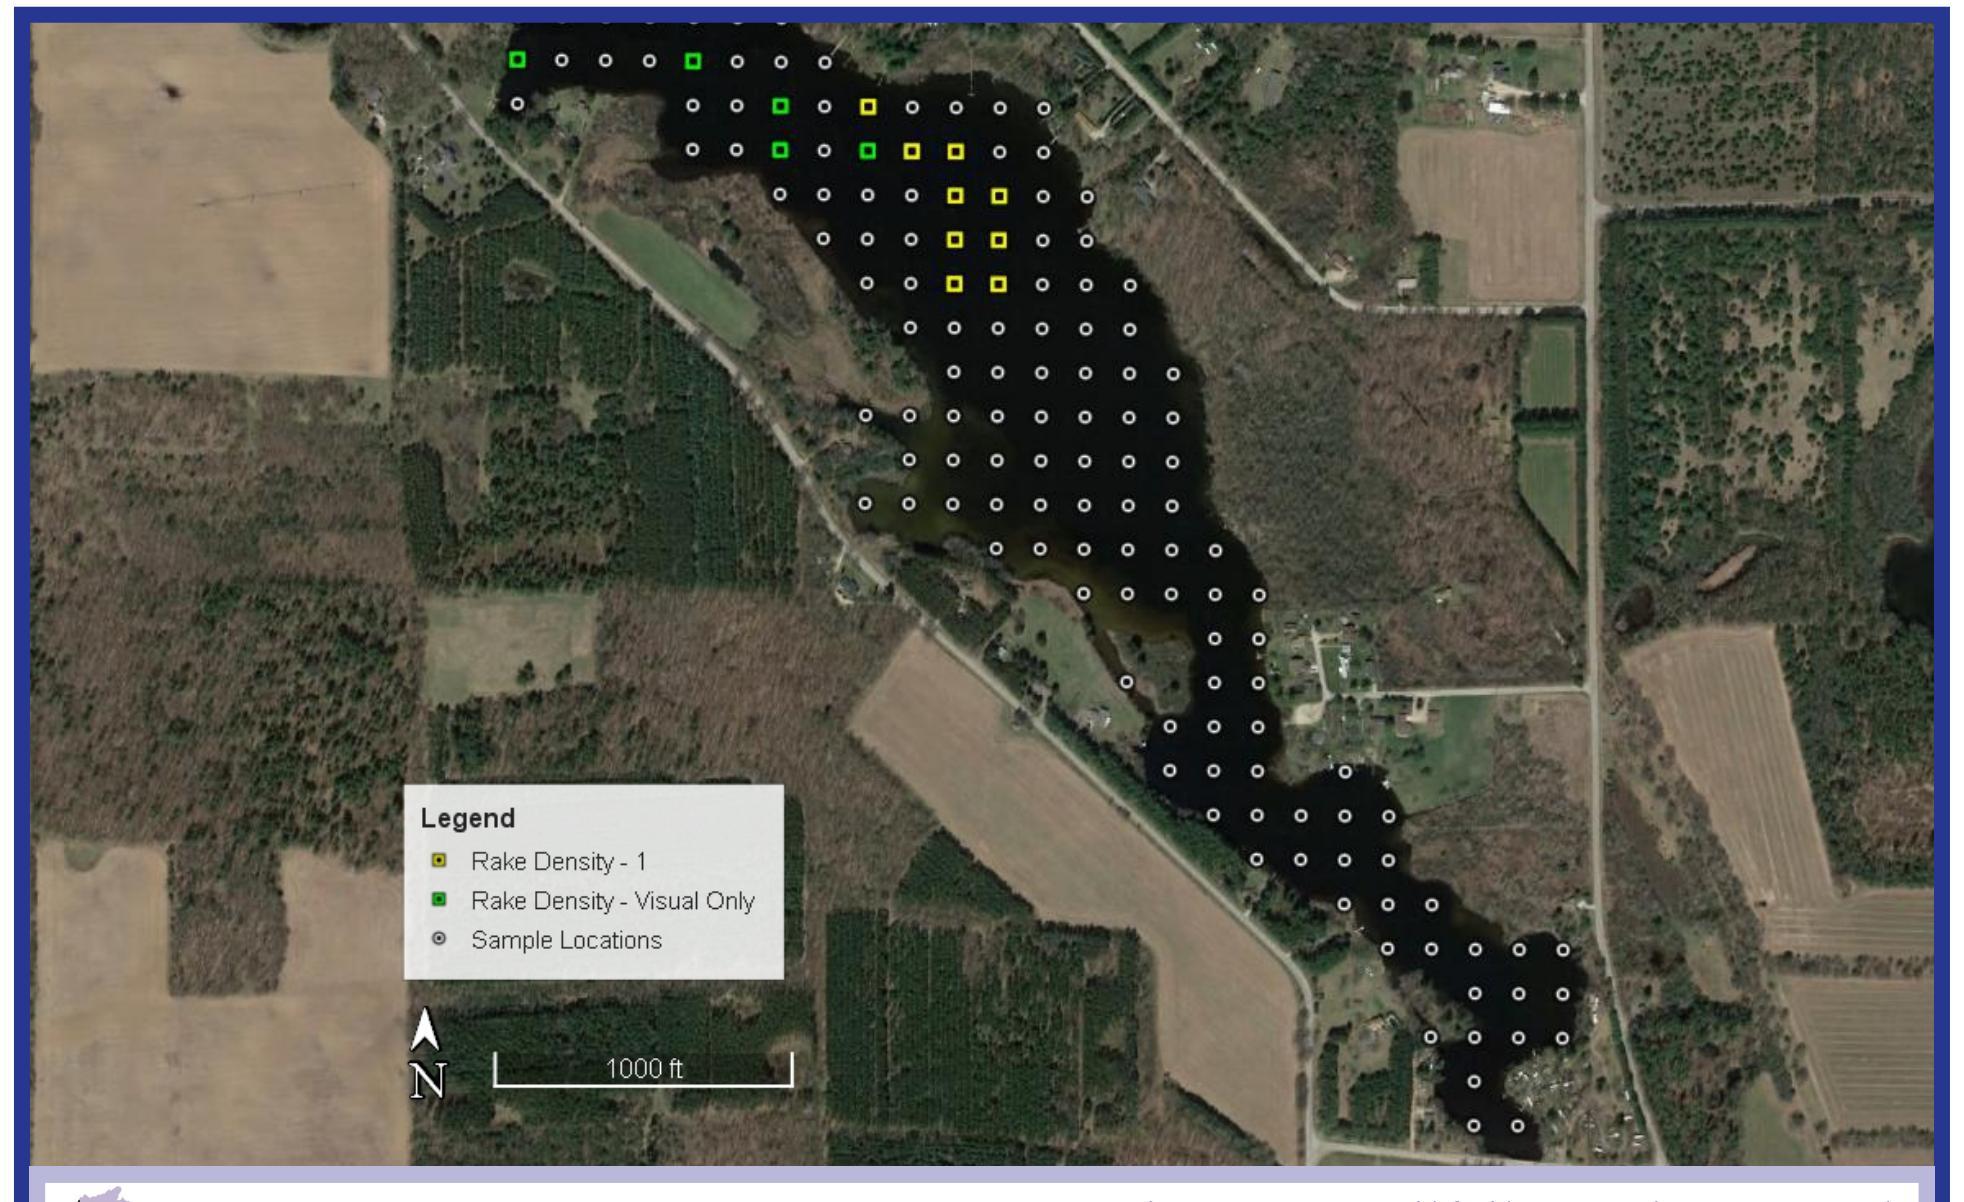
2018 Eurasian Water-milfoil Locations - South

Results of the EWM and CLP applications in 2016 were positive as both species saw a reduction in presence from 2015 pre-treatment to 2016 post-treatment surveys. However, both increased from 2016 to 2018 without active management in 2017 (Attachment B, Table 4). Remaining populations of EWM and CLP are scattered throughout the Flowage, as shown in Attachment A, Figures 1-4. Curly-leaf pondweed was found in only scattered locations mixed in with surrounding vegetation and in no defined beds of dense growth. Eurasian water-milfoil growth was concentrated in the central portion of the Flowage with a dense, 7.25 acre area outline for management in 2019 (Figure 7). Flowering rush was noted as scattered clumps outside of the dense, ground zero location (Figures 5-6). Additional mapping was completed by Golden Sands RC&D.

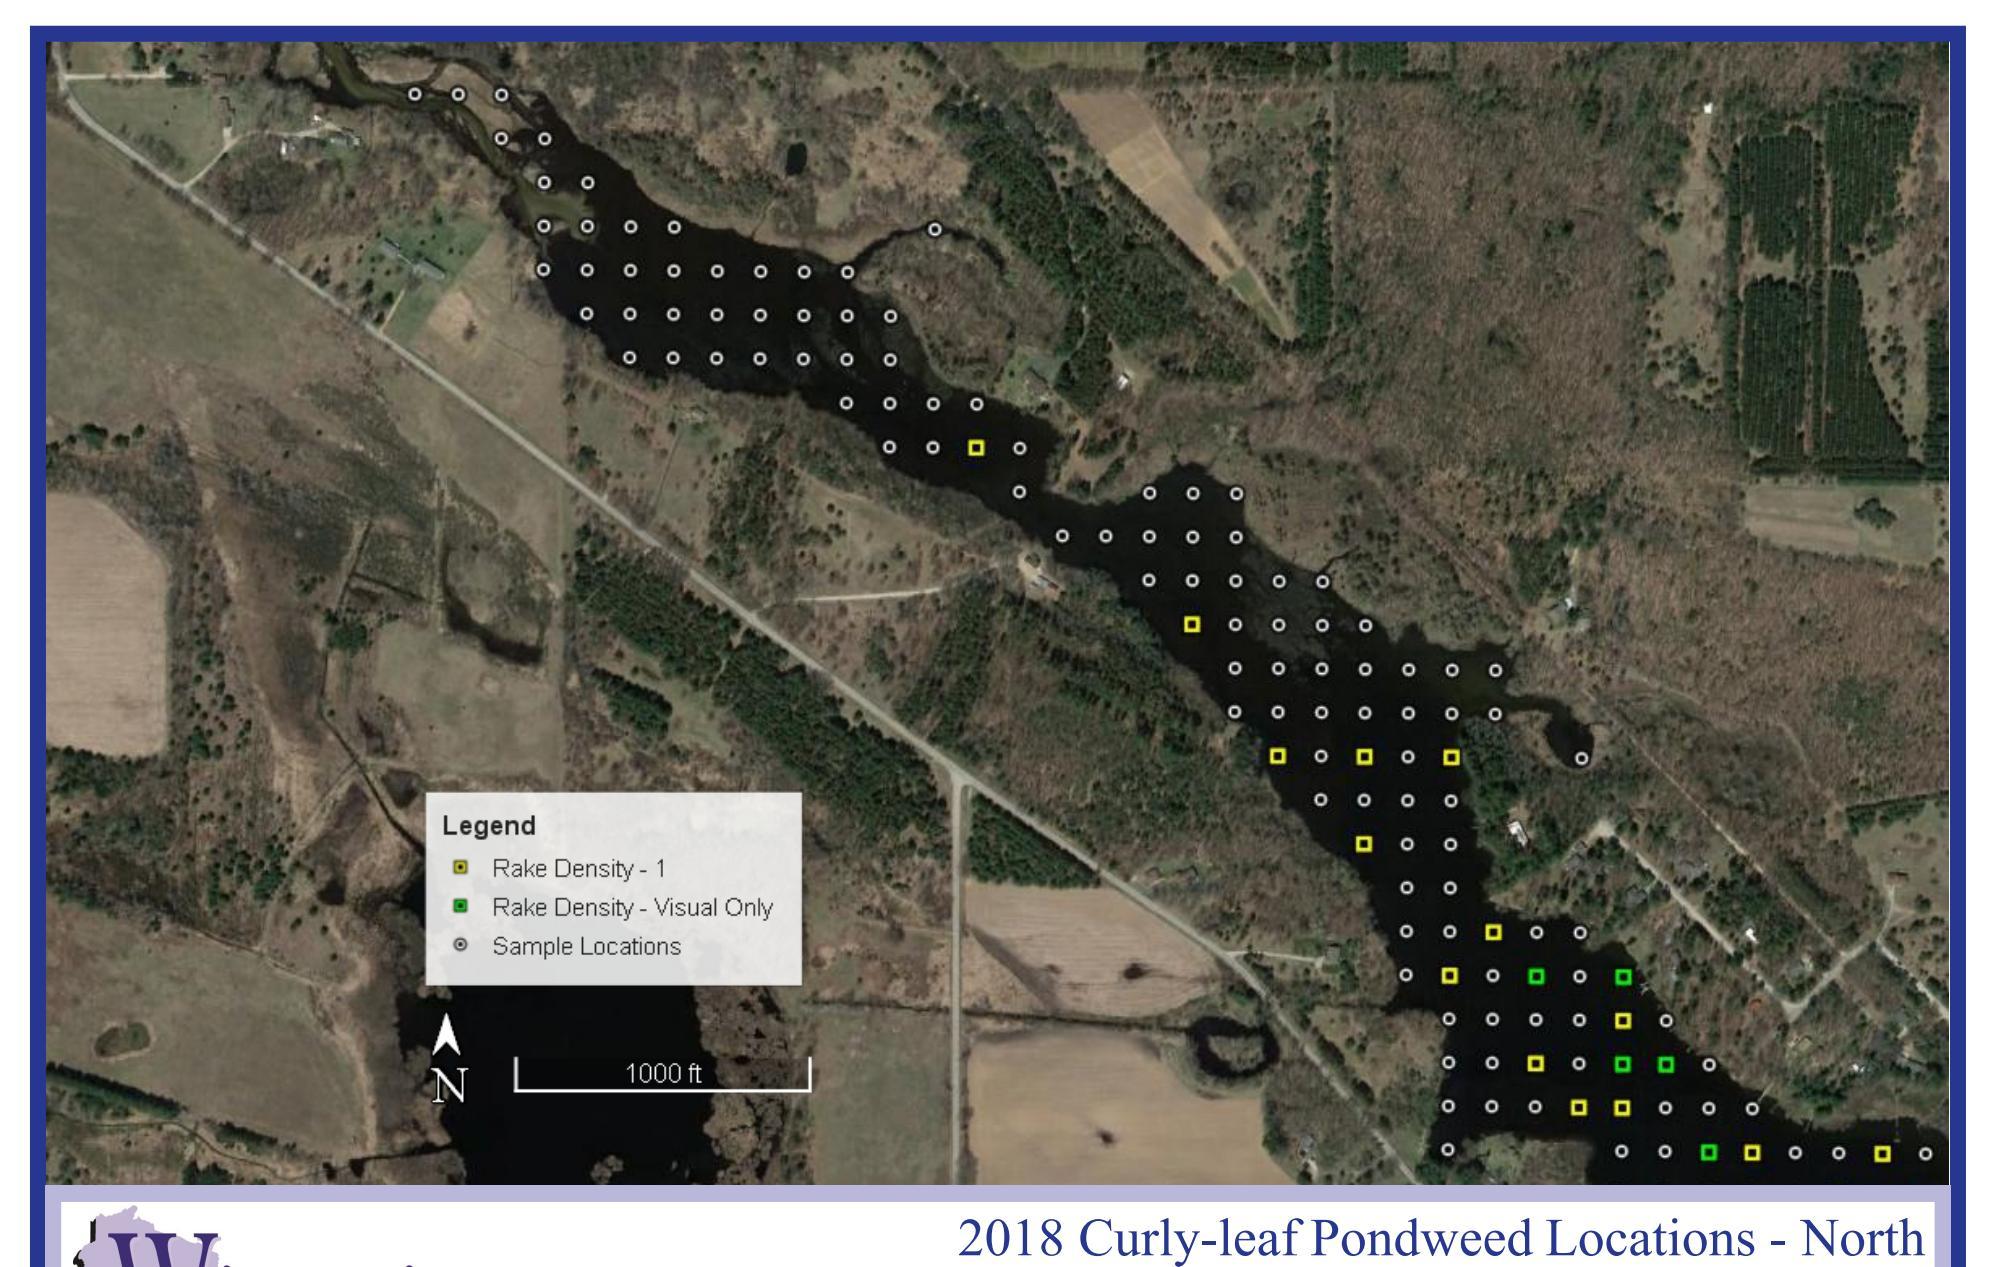
Figure 3

White River Flowage, Waushara County Survey Date: June 4, 2018

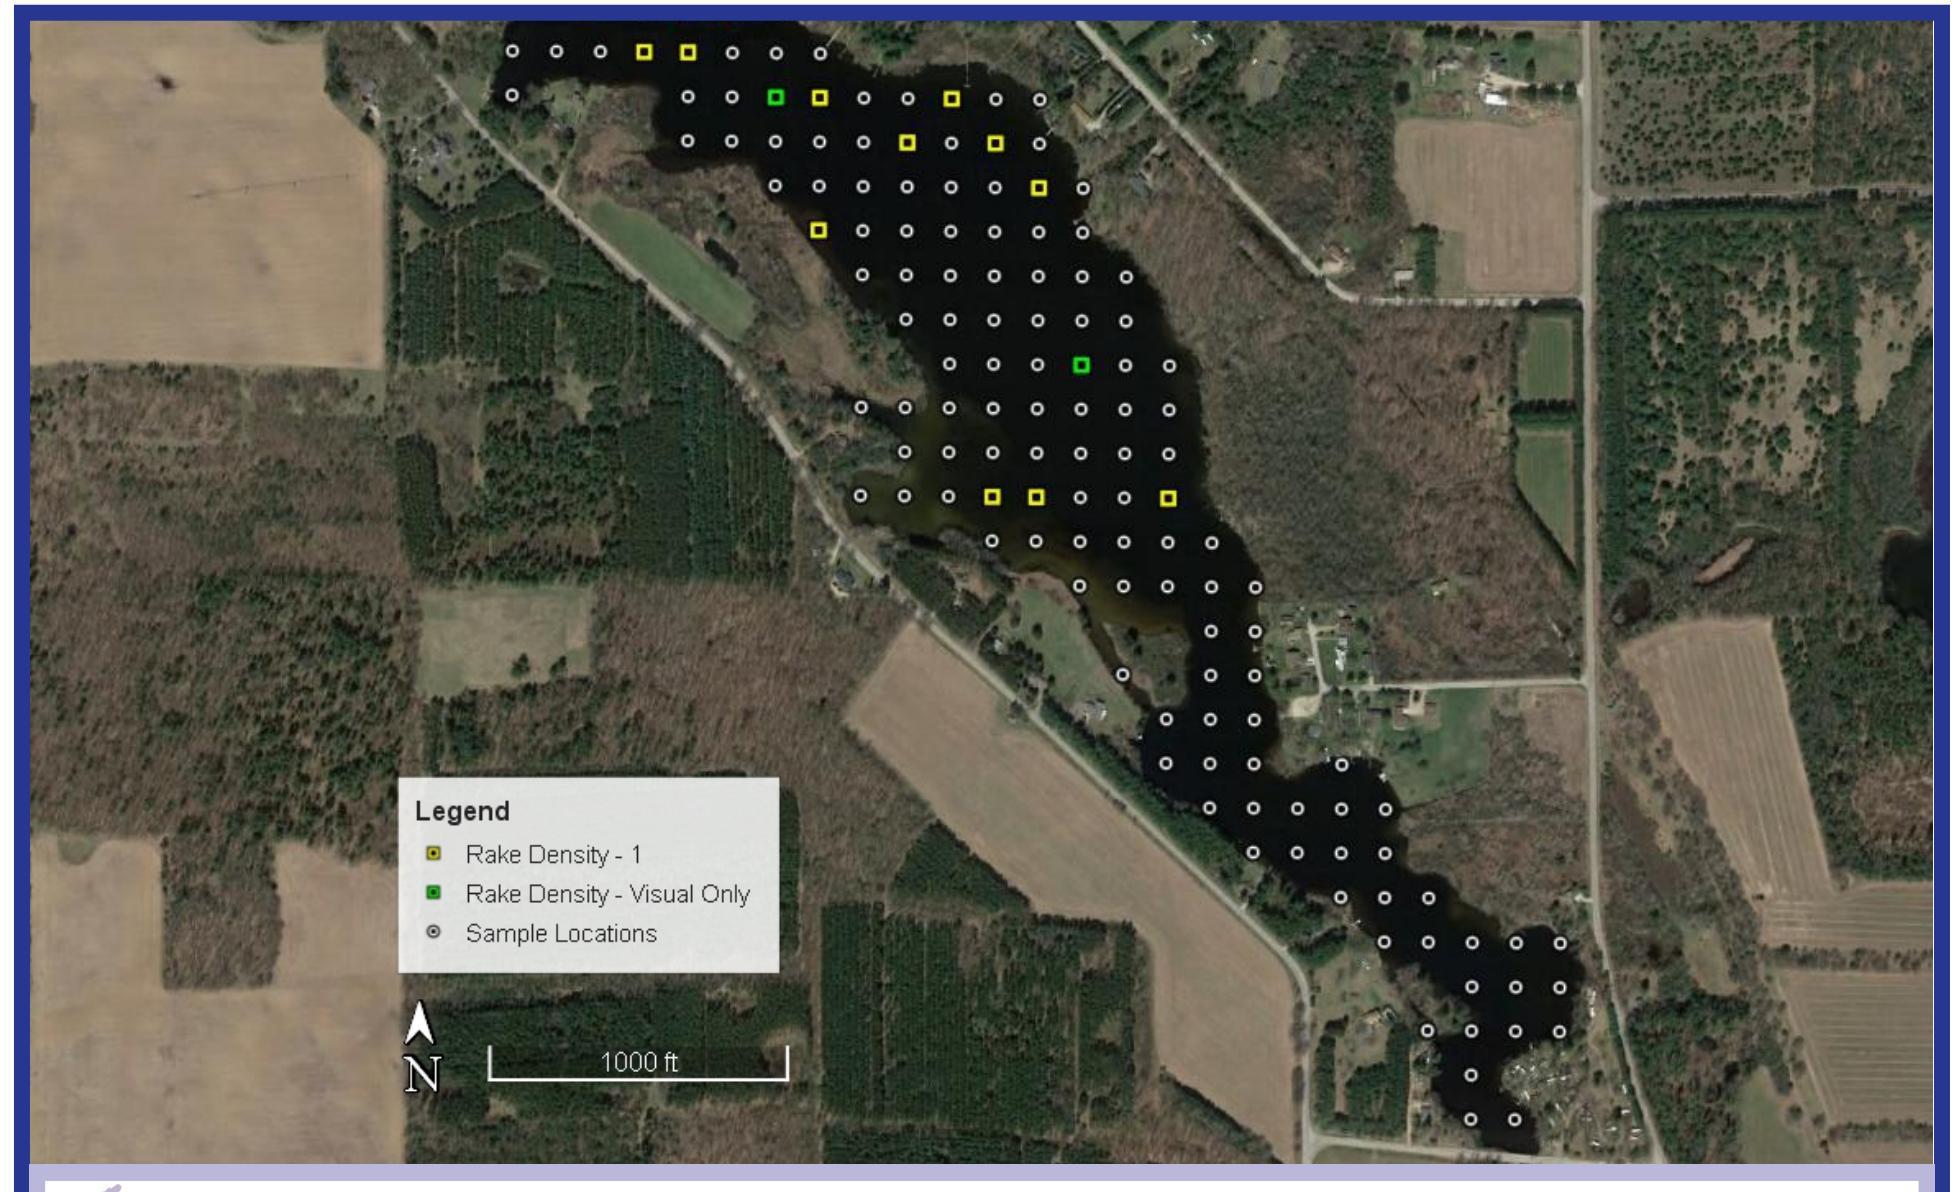
Survey Date: June 4, 2018 Figure 4

2018 Curly-leaf Pondweed Locations - South White River Flowage, Waushara County

The infestations of EWM and CLP have been monitored since the last management indicating a slight increase. Populations of CLP were very scattered and intermixed within native vegetation with no definitive beds present. Due to this, no direct herbicide management of CLP for 2019 is recommended. However, the population of EWM has increased since 2016 and is primarily located within a central, 7.25 acre bed (Figure 7). Since the White River Flowage has continual flow through any target application area a fast-acting herbicide mixture is recommended. The use of Aquastrike, a combination of diquat and endothall, has shown excellent, longer lasting results in similar situations and should be used in 2019 to control EWM. When applied early in the season as EWM is just emerging it has shown significant reduction of the target species with minimal negative effect on native plants in or outside the treatment areas.

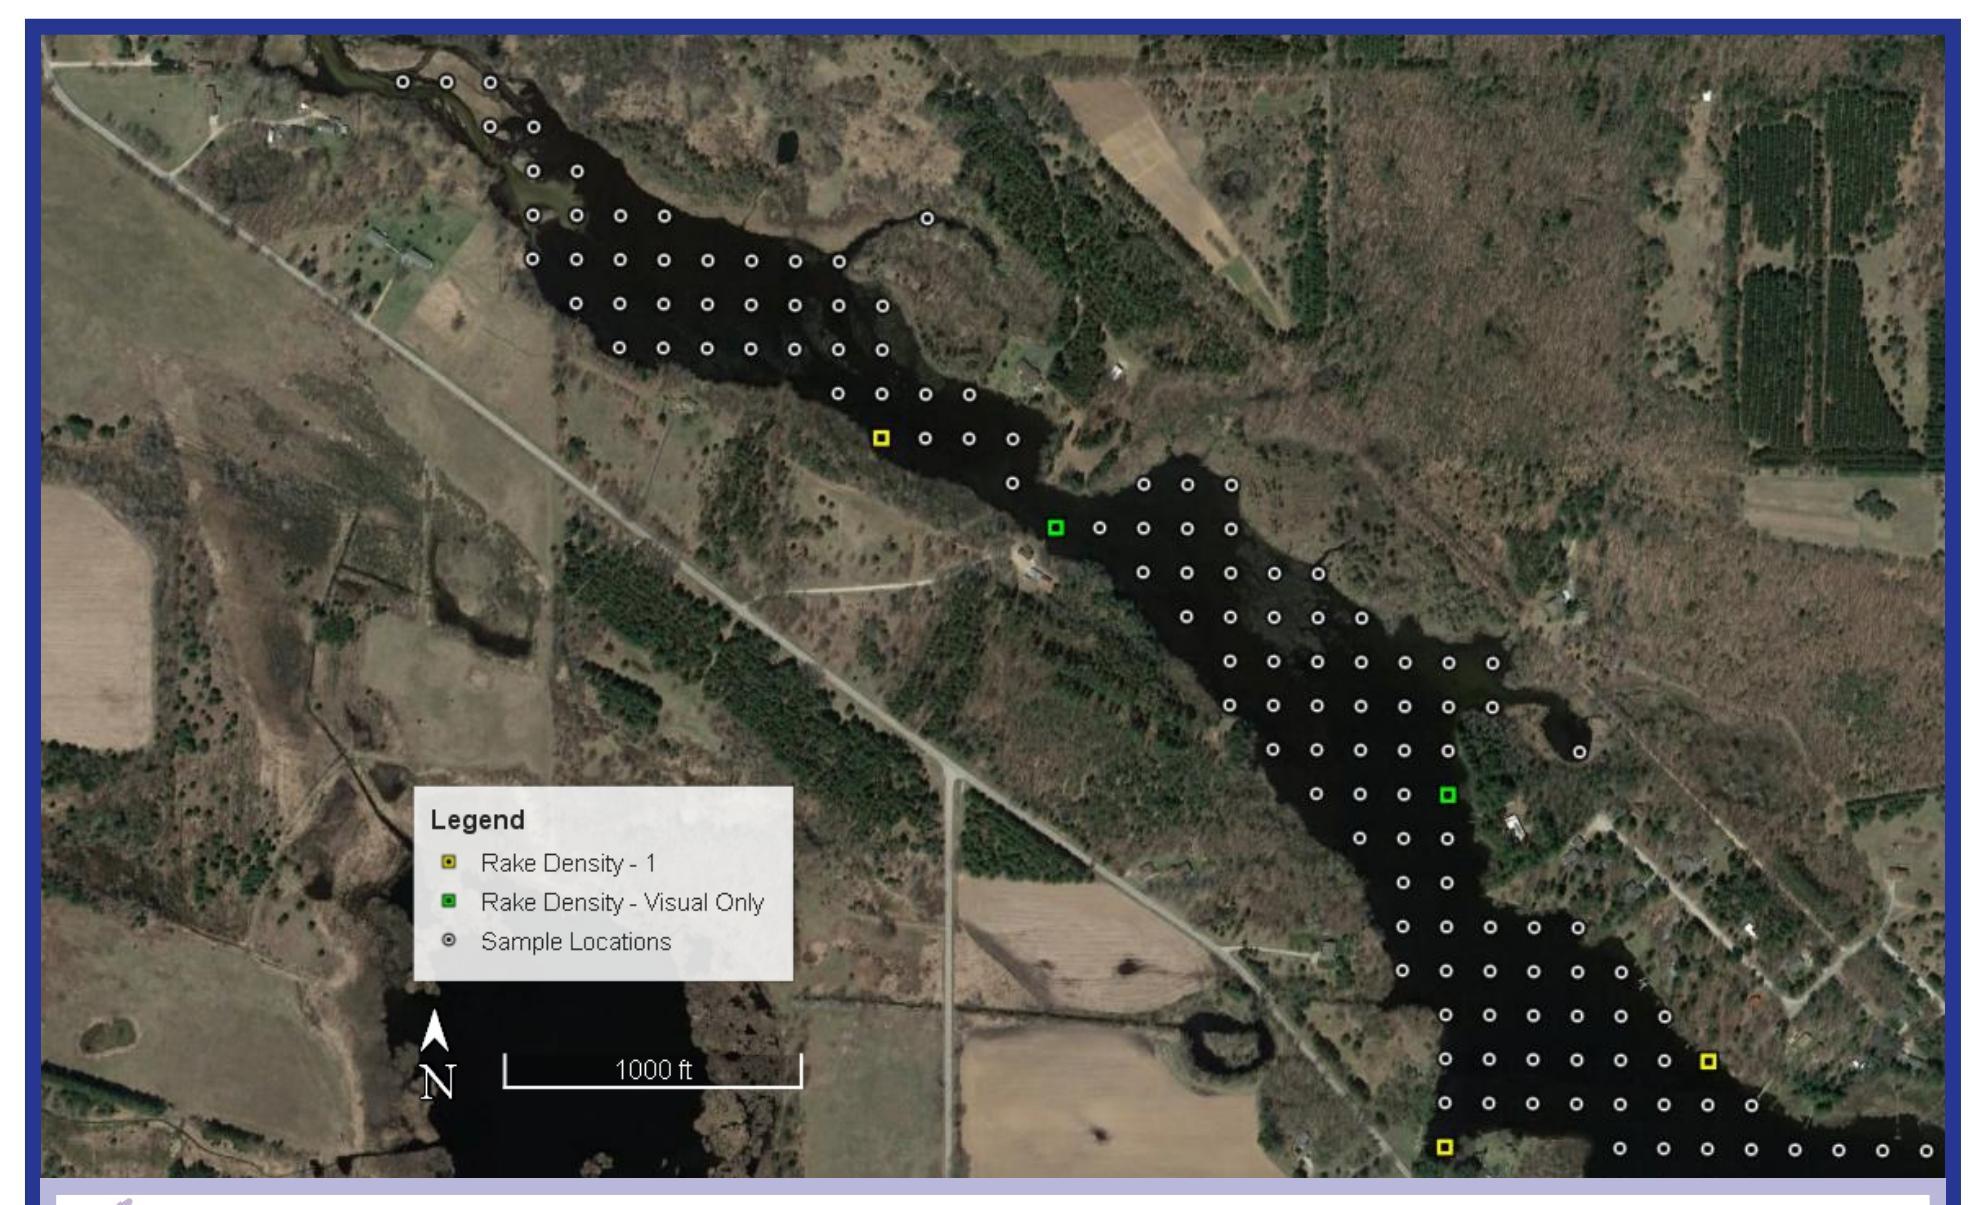
2018 Flowering Rush Locations - North

The same area was again targeted in September, 2017 with the active ingredient imazapyr, a systemic herbicide. Due to the later timing to target the plant as it prepares to over-winter results would not be known until regrowth in 2018. Initial reports from within ground zero in 2018 are positive with a substantial reduction in density.

For flowering rush, the continued use of a systemic herbicide that is translocated into the roots and therefore kills the plant in this way is recommended. Initial results of application using Habitat® (AI – imazapyr) in the Flowage from 2017 are promising. It appears that longer term control is possible and, more importantly, this active looks to have strong impact on the root stock of the plant. Plants like flowering rush that spread through asexual rhizomes begin to store nutrients within the roots in early fall to prepare for overwintering. This is an ideal time to treat flowering rush and this same technique has shown great success on controlling the highly invasive common reed (Phragmites), which also spreads primarily through rhizomes.

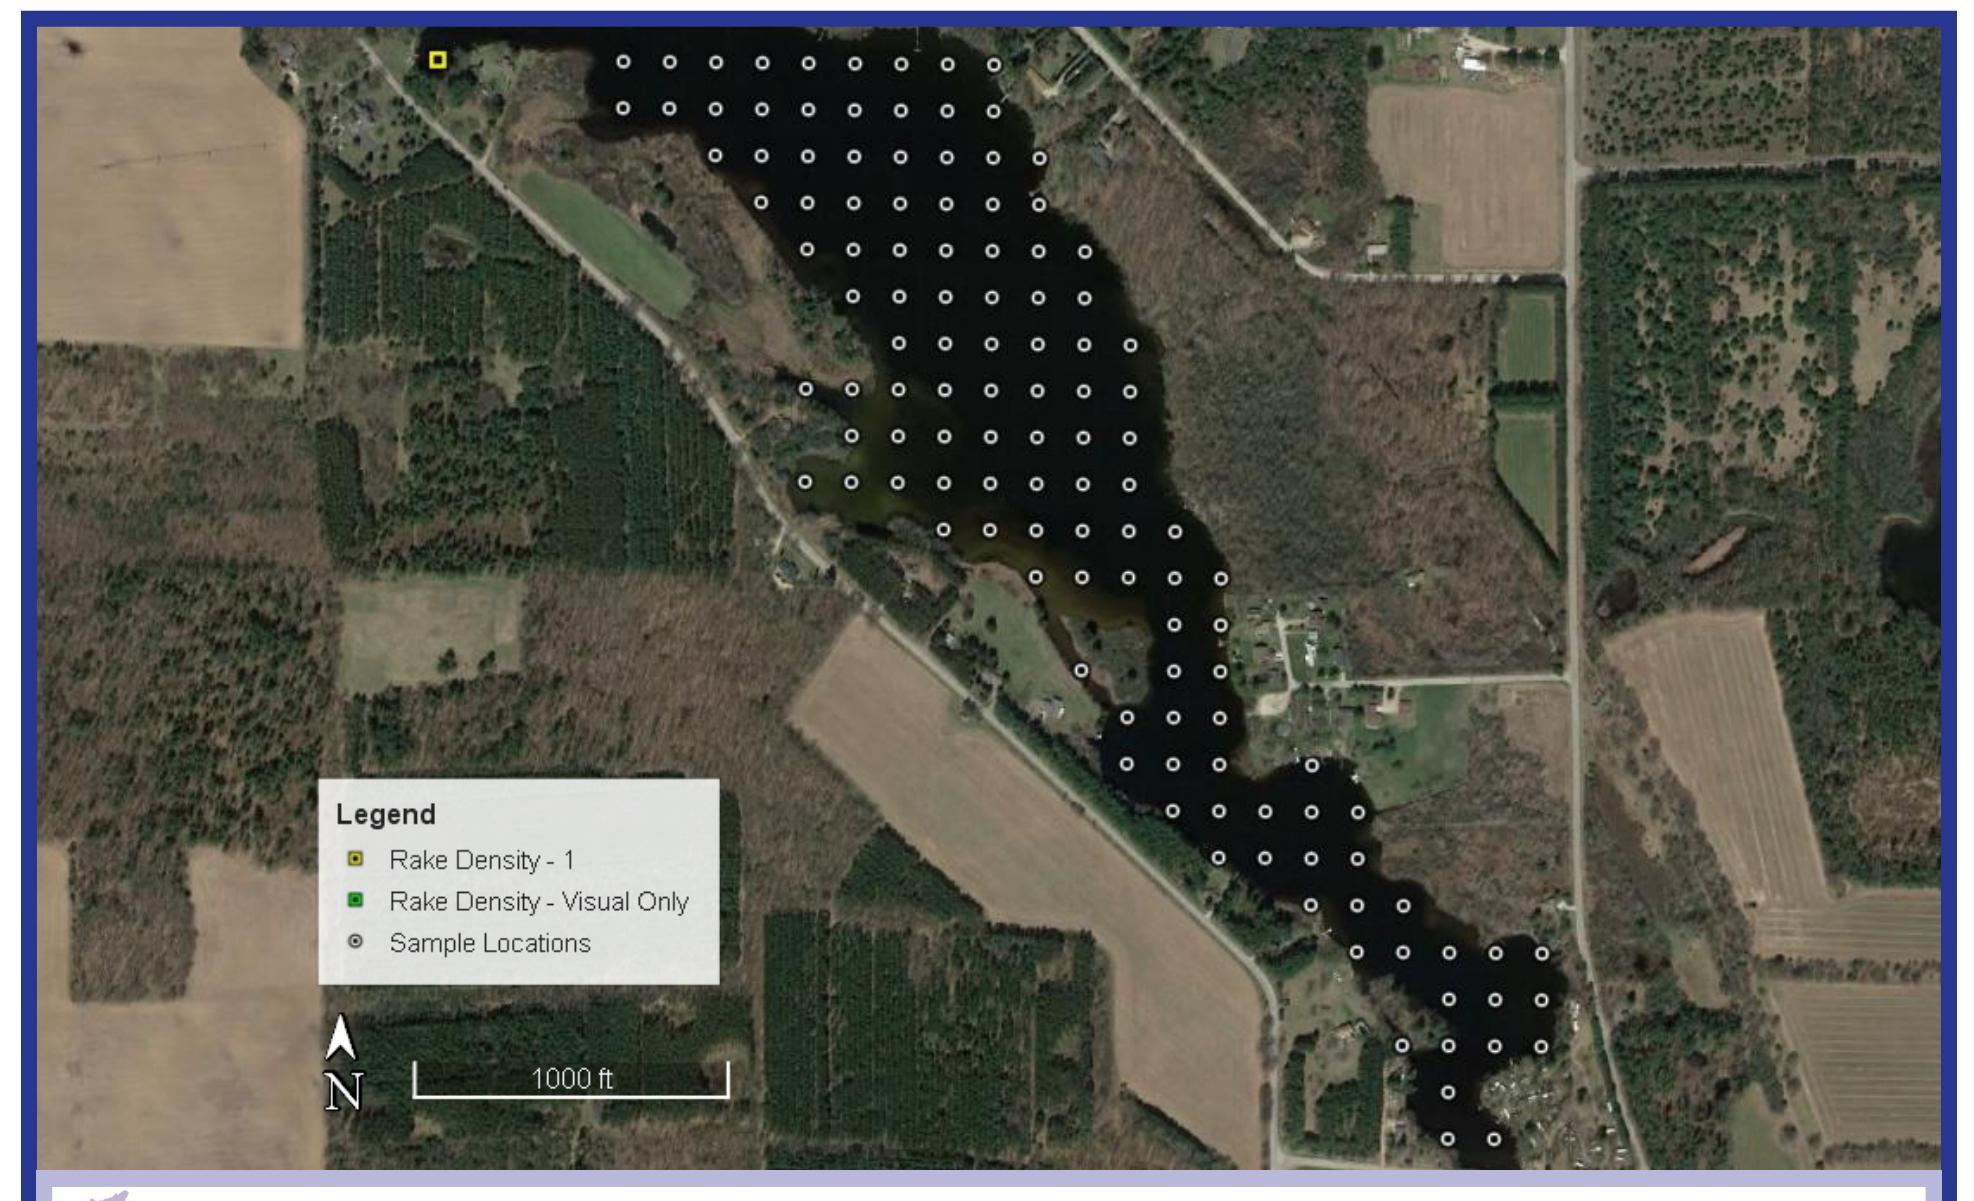
2018 Flowering Rush Locations - South

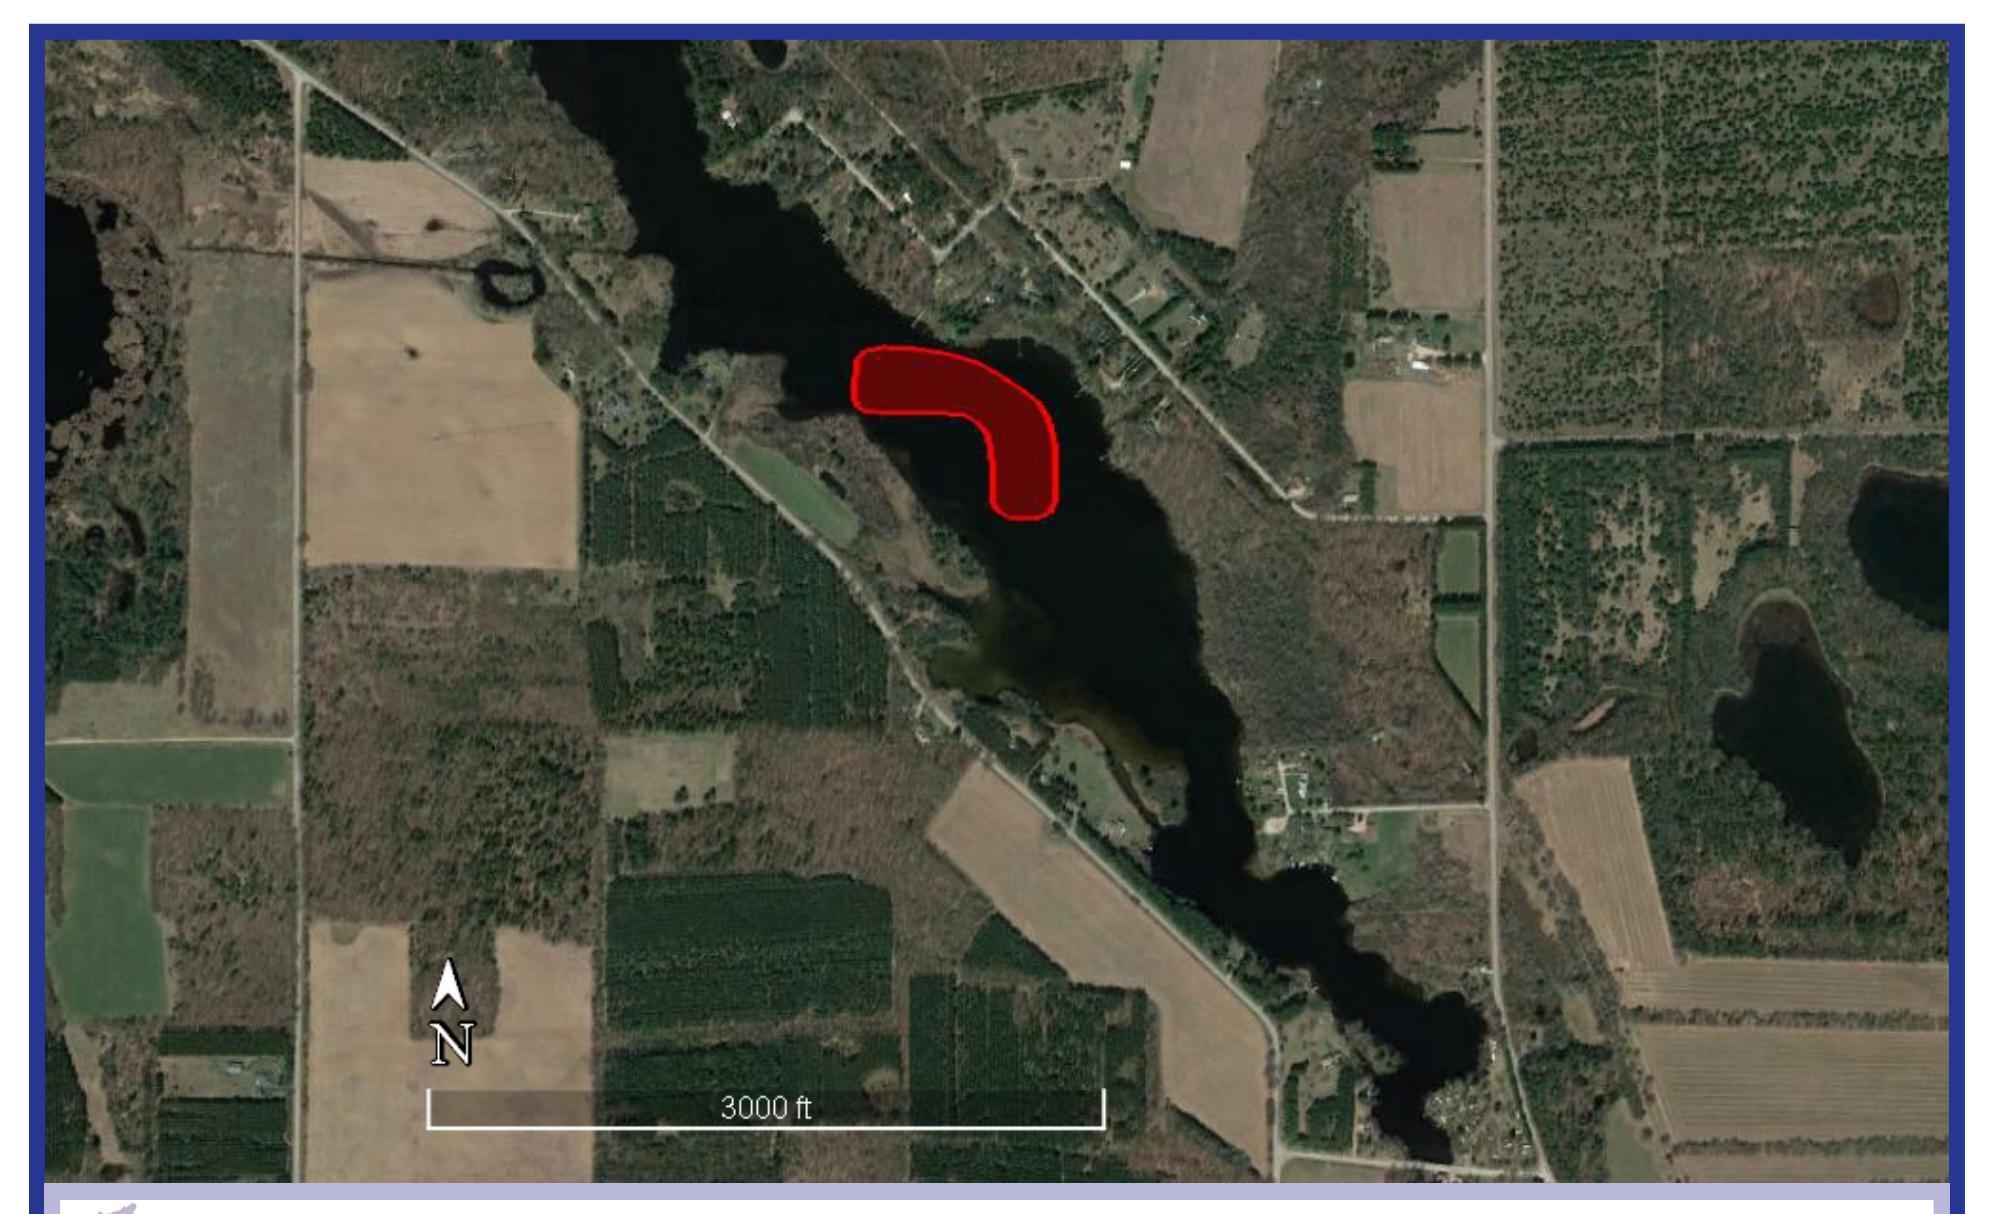
2019 EWM Treatment Location - 7.25 acres
